A solution to improve energy efficiency and productivity  
in process industries

Company, Cases in Food, References, and value drivers for customers

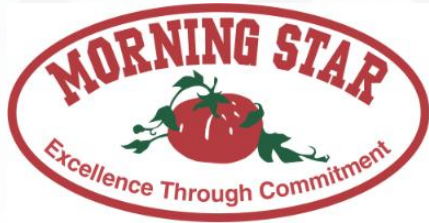
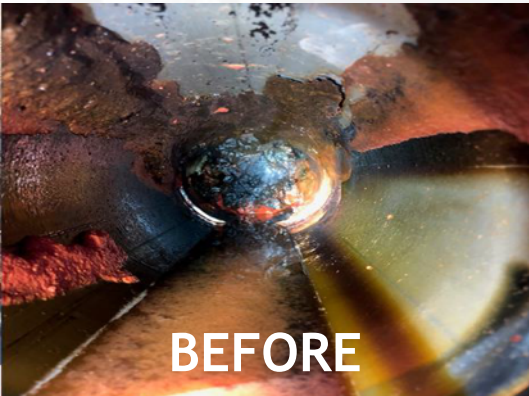
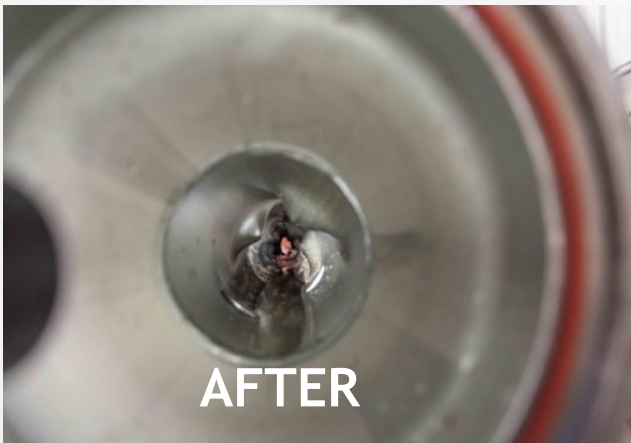
The client was running a max of 7-10 days production runs before needing to do a CIP wash, as steam nozzles were getting clogged and burnt particles were contaminating end-product and causing quality issues.

To prevent tomato paste from sticking and burning in the inner walls of the steam injector to avoid product quality issues and CIP cleaning. Avoiding these issues will also increase the production capacity.

Thanks to power ultrasound, now they produce the whole 85 days season without the need to do any chemical/CIP or mechanical cleaning and have 0 quality issues.

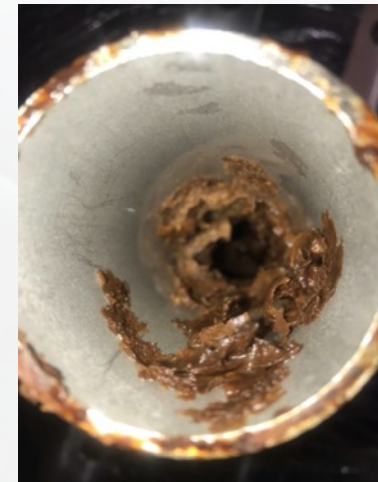
After 5 min of sonication

These were possibly the most impressive results. We filled the burnt pipe with water and sonicated with the same 1+4+10 structure.

- With 1 minute sonication fouling structure collapsed,
- within 5 minutes there were only few patches left, and
- within 15 minutes the pipe was shiny clean.

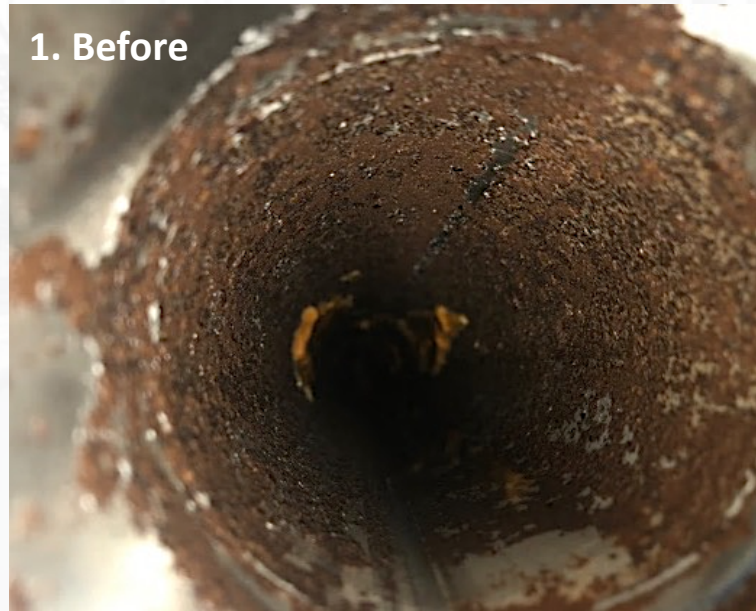
Removal of Maillard reaction fouling in pipes by Software-Guided power ultrasound. Image 1: Pipe after CIP without sonication. Image 2: Pipe after CIP with simultaneous sonication for 30 minutes.

Either caramelized sugars or Maillard reaction residues are difficult for chemicals to remove. They need much surfactant additives and even with them, washing performance is often poor if layer is anyhow thick. There are found in many heat treatment and hot extraction processes.

Ultrasound is able to crack this layer and helps cleaning chemicals to affect deeper and remove burnt residues.

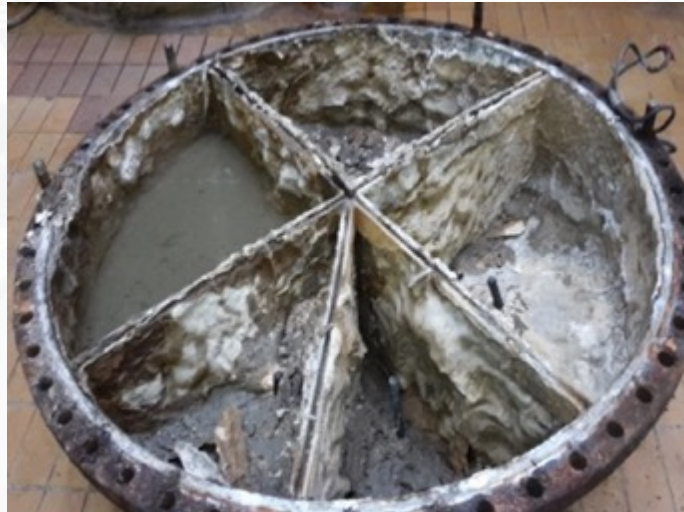
1,3m diameter, 6m high  
seawater heat exchanger used for  
vacuum creation

Fouling in 3 months decreases  
energy efficiency by 25%

Before

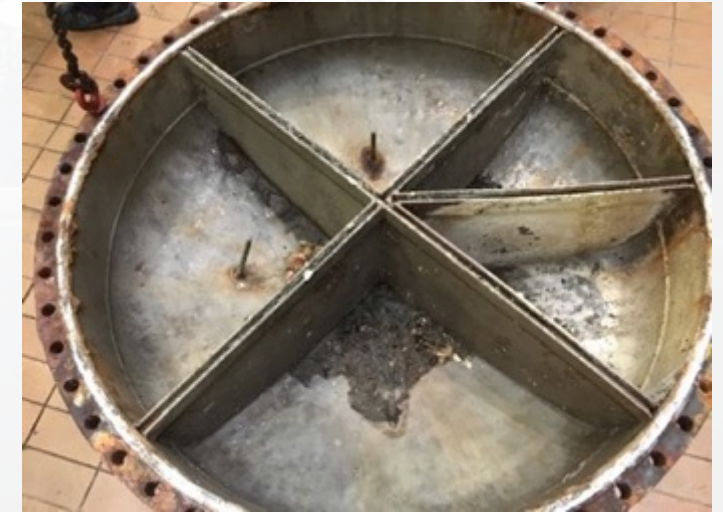
After

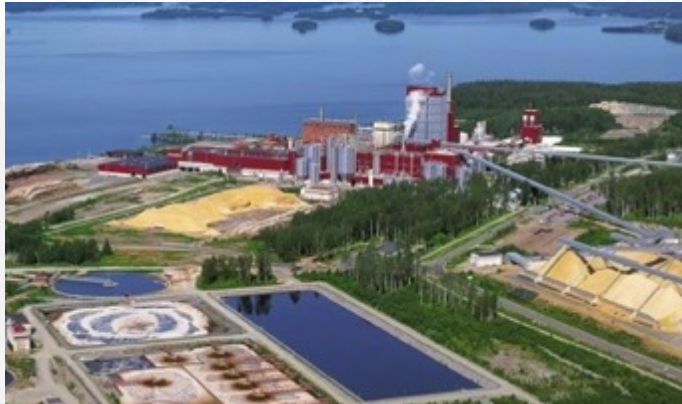
Annual mechanical cleaning dropped from 24 to 1

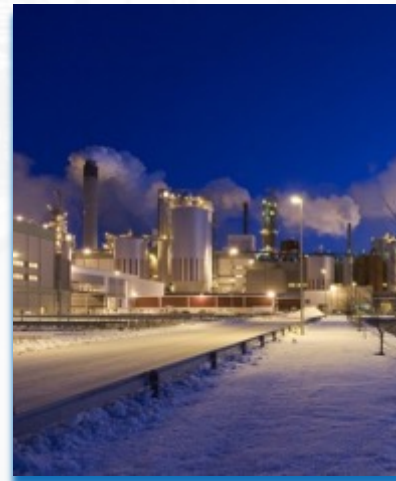
Heat transfer capabilities increased by 57%

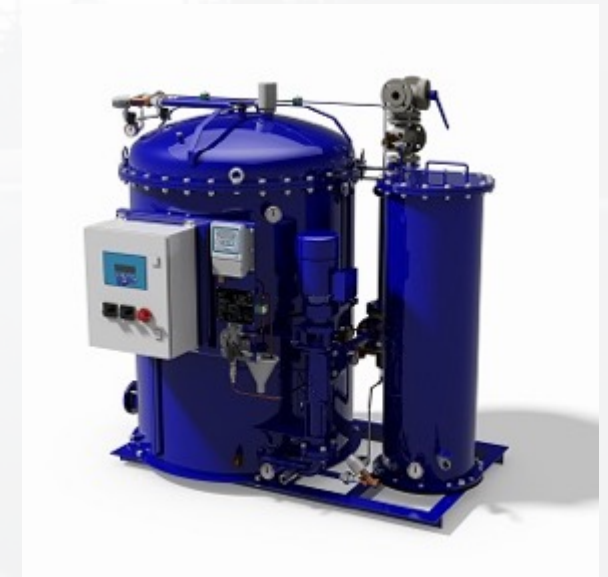
Increased separation efficiency significantly

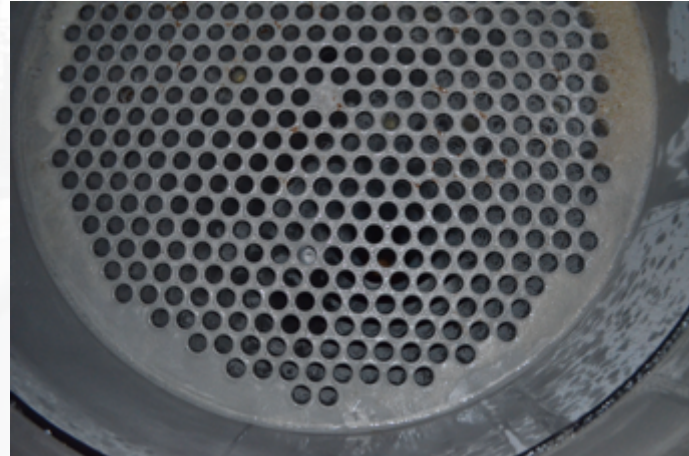
Heat transfer capabilities increased by 30%.

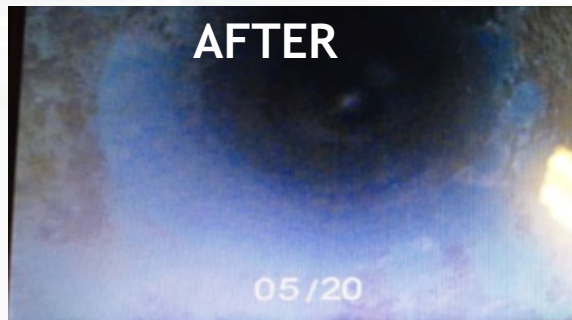
Hardened fat fouling was completely cleaned.

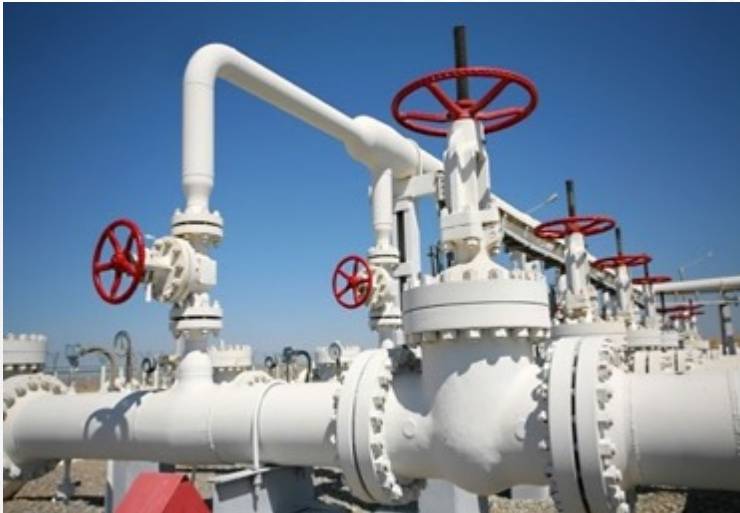
Fouling was removed and customer was able to close the valve.

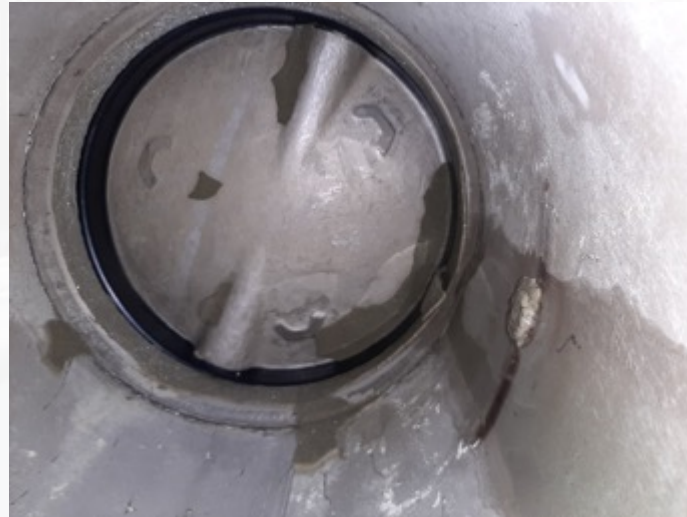
Fouling was removed and the valve could be operated normally

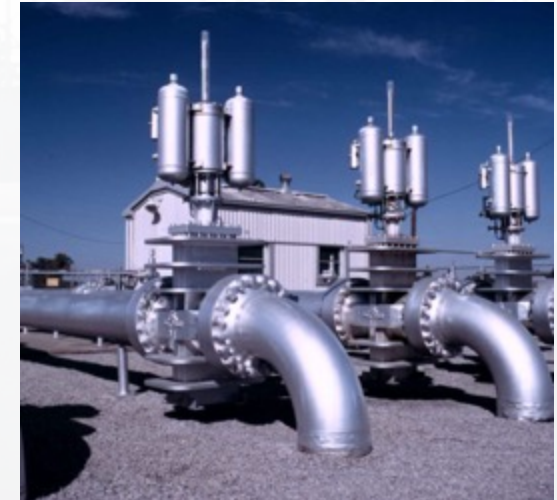
Normal valve operation restored after sonication
